Editorial

Special Issue: Results of the II National Research Project of AIAR: Archaeometric Study of the Frescoes by Saturnino Gatti and Workshop at the Church of San Panfilo in Tornimparte (AQ, Italy)

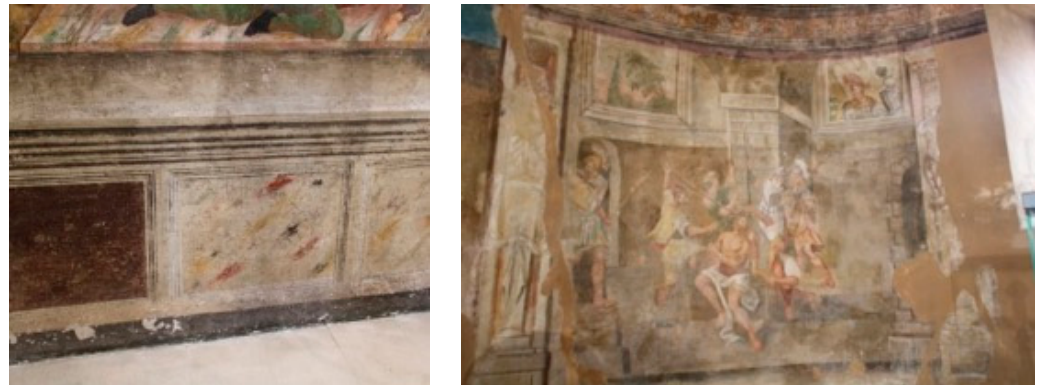
Figure 3. Examples of typical alterations found in the lower and upper portions of the apsidal basin.
