Assessment of piping-sinkhole development in a fluvial-terrace scarp retreat environment: A multi-temporal analysis on the lower Ticino River (Italy)

This paper investigates, from a geomorphological and hydrogeological point of view, the development of piping-sinkhole phenomena at a retreating fluvial-terrace scarp along the lower Ticino River, near Casottole, northern Italy. Piping forms and features are well documented in the literature as complex soil erosion phenomena, usually associated with clayey or carbonate substrata, or to specific fluvial deposits. Such phenomena appear to have never been mapped in the lower Ticino area, and up to now, no evidence of piping-sinkhole occurrence in terraced alluvial plains strictly associated with terrace scarp erosion processes have been observed and reported in the literature. The geomorphological peculiarities of the area were assessed through field surveys, photographic and drone imaging, photointerpretation, and GIS analysis. Moreover, the riverbed morphological evolution was evaluated since the 1950s, and the hydrogeological conditions were analysed. Finally, a large piping-sinkhole database composed by 35 landforms was assembled in

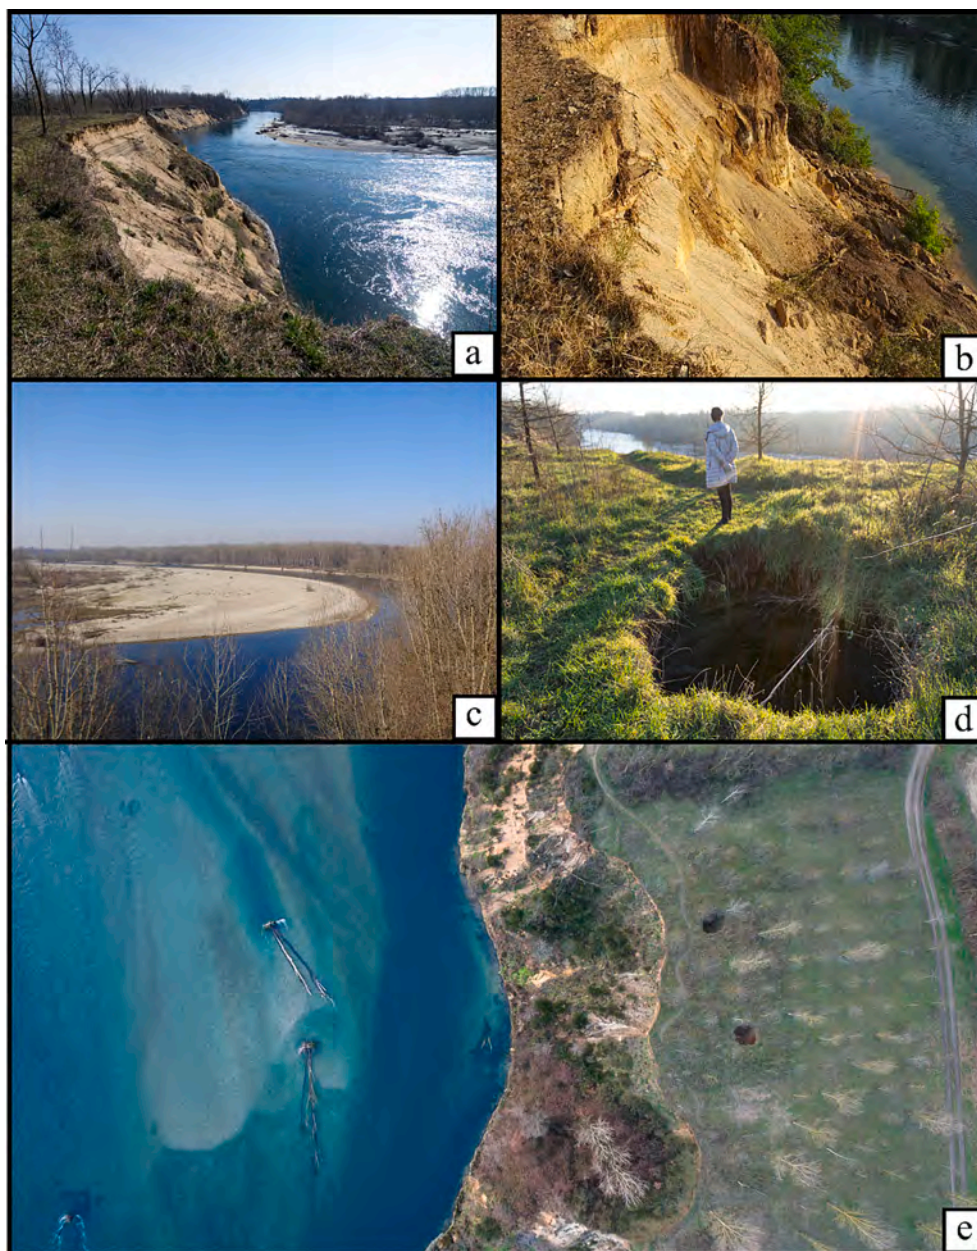
Fig. 2. Landforms in the study area. (a): The Ticino River and retreating fluvial-terrace scarp. (b): Stratified sediments and slope instability evidence. (c): Point-bar. (d): Piping-sinkhole. (e): Drone view from above showing piping-sinkholes on the top of the terrace and associated to the terrace scarp.

confined concave side of a riverbed bend largely affected by erosional processes (Fig. 2a, b). The scarp is characterized by an alternation of heterometric gravel and sand layers, interbedded with finer-grained fluvial deposits. The granulometry as well as the observed sedimentary structures (e.g., cross bedding stratification) varies laterally along the exposed section. These deposits lie on the top of a continuous grey basal silty level. On the opposite (convex) side there is a large point-bar attached to the bank (Fig. 2c). In the upper and lower parts (N and S) of the study site scarp toe erosion triggers rockfalls causing a sub-vertical scarp (SVS) retrogression (Fig. 2a and b). In addition, on the top of the oldest river terraces, directly facing the river, sub-circular piping-sinkholes can be mapped (Fig. 2d and e). Finally, in the central-northern part of the area and locally in the southern part, large sub-circular niches can be observed where the fluvial deposits crop out in the riverbank (Fig. 2e), which are directly associated to the fluvial-terrace scarp.

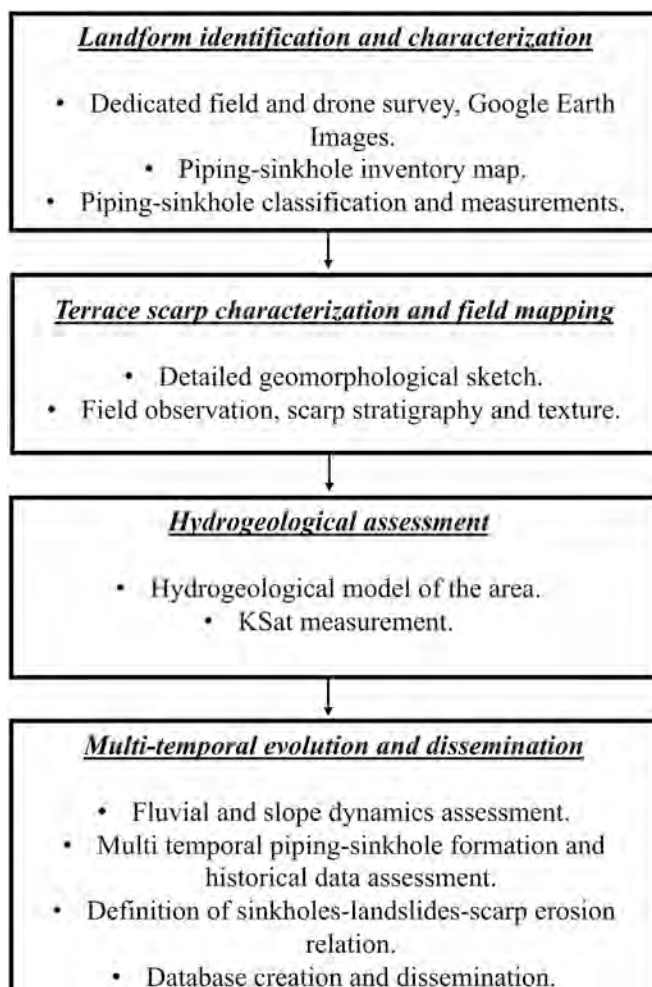
Fig. 3. Flowchart explaining the adopted methodology.

The methodology followed to assess the morphological evolution of the area (Fig. 3) is based on fieldwork including geomorphological observations and mapping as well as field measurements, realization of hydrogeological cross-sections and finally laboratory and GIS analyses.

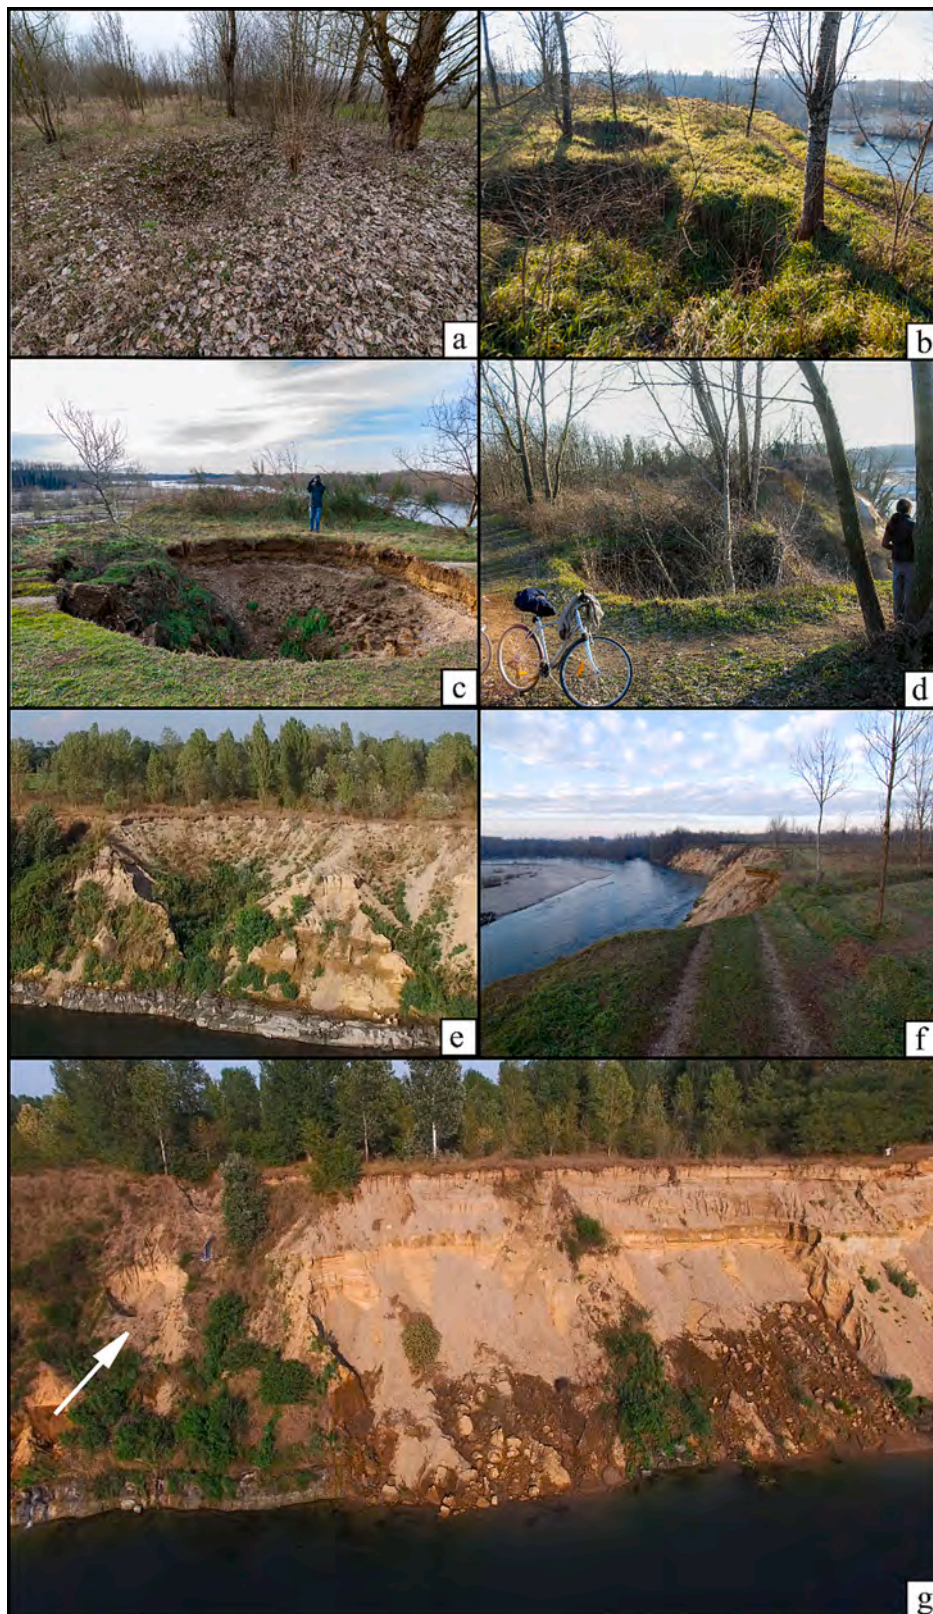
Fig. 5. Piping-sinkhole and scarp erosion evidence in the study area. (a): inactive small PS (PS-6), 30 m from the river scarp. (b): recently formed PS near the scarp edge (PS-8). (c): large active PS close to the terrace scarp (PS-2). (d): terrace scarp retreat crosscutting the PS (PS-1). (e): SPS directly associated to the fluvial-terrace scarp. (f): path interrupted due to the fluvial-terrace scarp retreat. (g): linear scarp covered by talus on which springs can be observed. On the left, indicated by the arrow a small SPS (SPS-12) has directly formed on the scarp.

L4 and L5 (Fig. 5g, Appendix D) and this level appears to play a major role in the development of the recent SPS-18. In the steeper scarp areas, the dominant erosional process is represented by scouring at the scarp toe, sometimes facilitated by strong underground water flow at the base of the escarpment as testified by abundant mud-rich springs emerging near the base, documented by drone images weeks and days before a major landslide (Appendix D).

In the study area PSs sensu stricto (Fig. 5a, b, c, and d) develop on the top of the Ticino River terrace up to a few tens of meters from the scarp edge and are in average 1.7 m depth and 4 m wide. While we do not exclude the contribution of vertical flow of water caused by fluctuations of the water table and consequent upward propagation of cavities, as in

documented on the scarp and within SPS-18 corresponding to the L4/L5 interface (Fig. 5g, 7b, Appendices B, D). Although the L4 layer is barely located into the silty sand area of the Shepard diagram of Fig. 8, the textural difference with the L5 sand is sufficient to make this interface an important groundwater conduit.

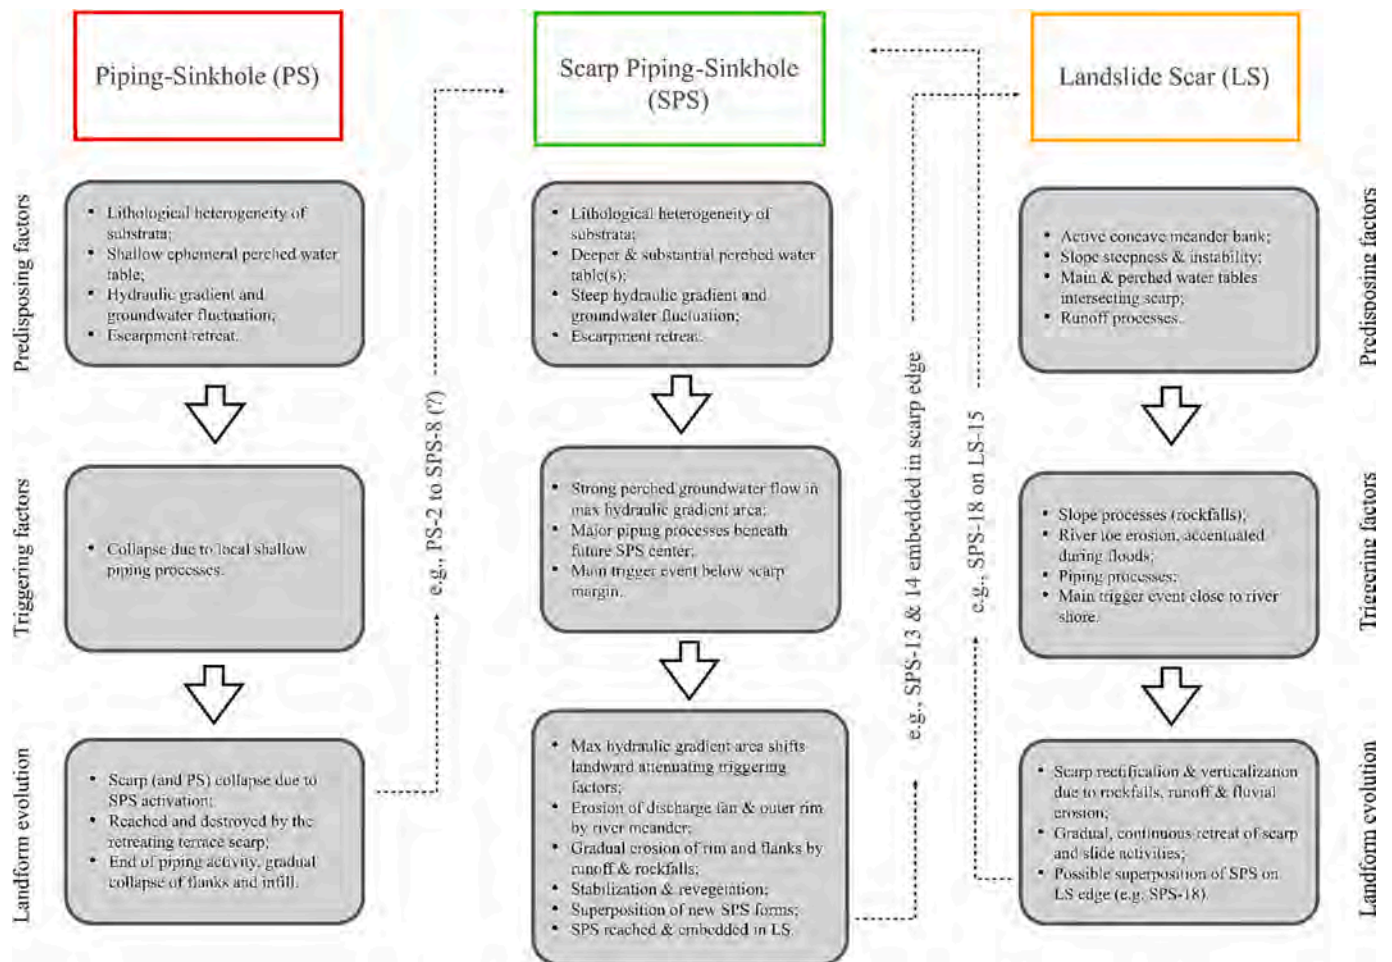
Fig. 12. Conceptual-evolutionary model of the landforms of the study area.

morphotypes are triggered by the same process i.e., piping, they present different morphologies and dimensions, and evolve in different ways in the area. A schematic conceptual-evolutionary model of PS, SPS and LS landforms is proposed in Fig. 12.
